# **The Commonwealth of Massachusetts**

### **PIPELINE ENGINEERING AND SAFETY DIVISION**

## **INCIDENT REPORT**

627 Pleasant Street, Winthrop, Massachusetts  
February 23, 2012

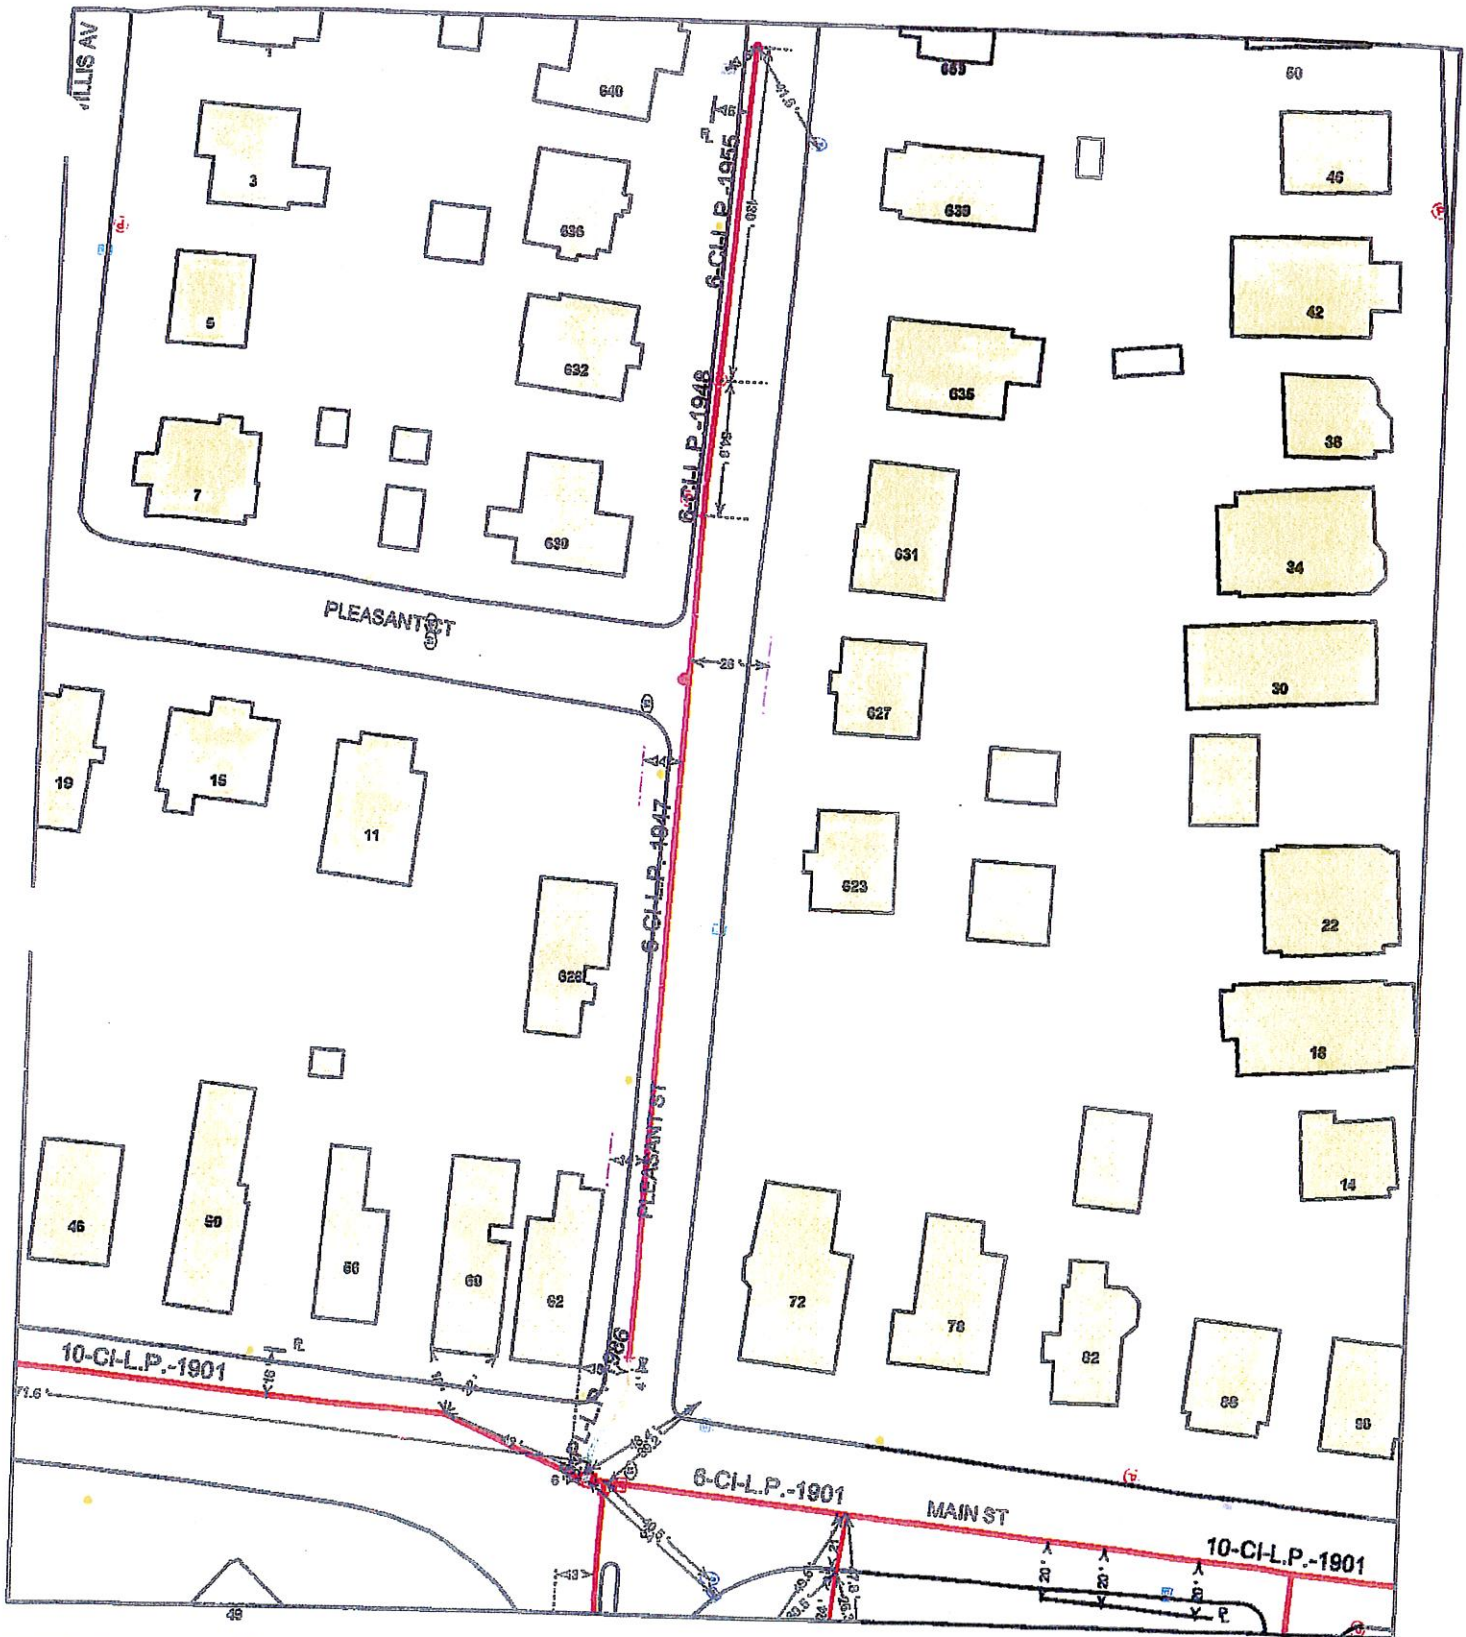
## 627 PLEASANT ST, WINTHROP

**Response:** The main that services 627 Pleasant Street, Winthrop is a six inch low pressure cast iron with various installation dates including, 1947, 1948, and 1955 depending on the section of Pleasant Street. The operating pressure is between 8 to 12 inches Water Column (w.c.) with an MAOP of 14 inches w.c. National Grid has no record of any main leaks between January 1, 2002 to February 22, 2012. Please see map of the main that was provided in response to IR PL 1-6.

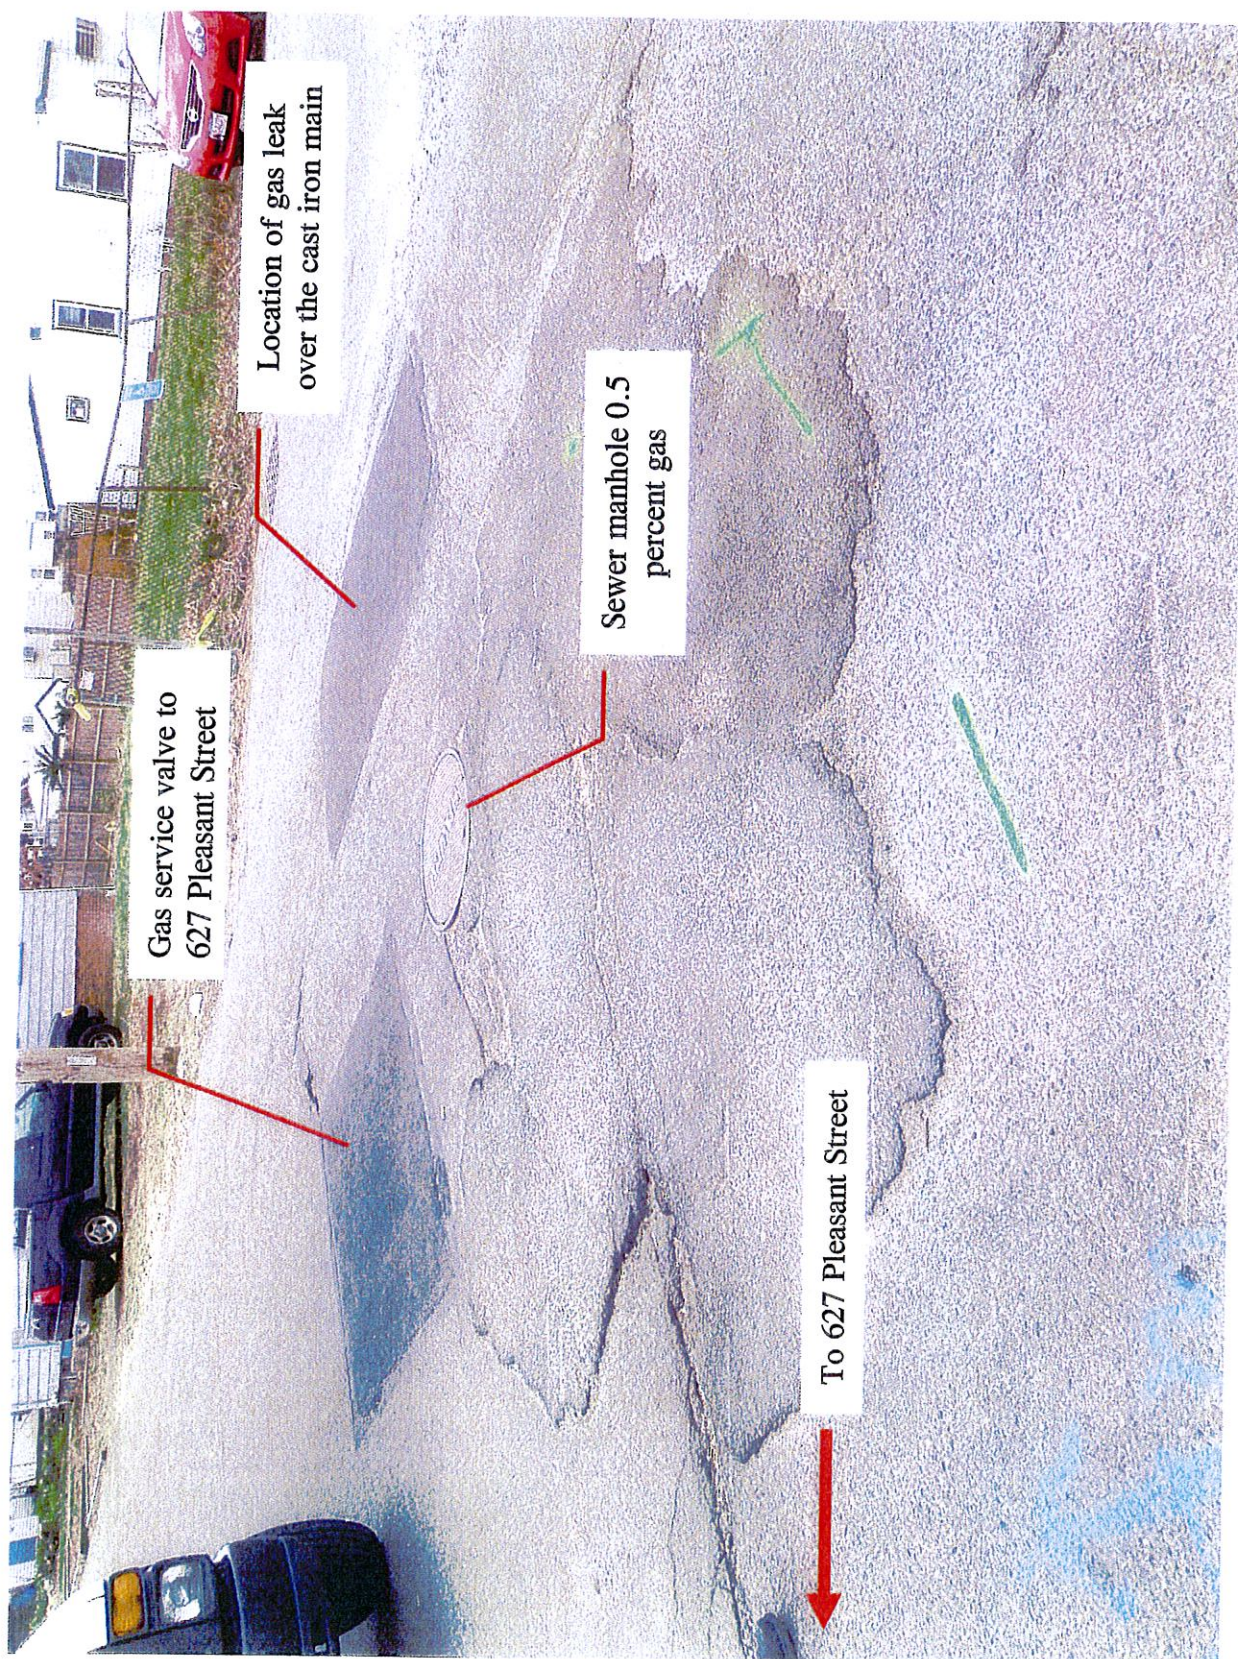
7(c) - Gas reading at curb

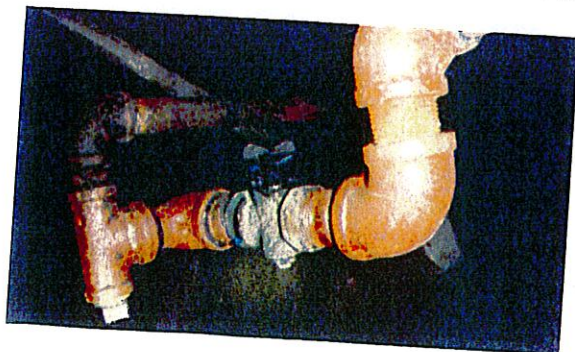
On April 9, 2012, the examination continued with the DPU and insurance investigators. Additional excavation was performed and a scope of the pipe was performed with negative results. A minor leak was documented outside the dwelling foundation. The scope procedure was videotaped and we have a copy on file if needed.

It is our continued opinion that the cause of the fire was from an internal source within the dwelling and not from the migration of gas vapors from outside the building. As previously reported, a gas valve located in the basement on the dwelling's side of the gas meter was found to leak as indicated by the bubbles from test soaping and was the most

probable cause for the gas vapor fire in the basement and other areas of the dwelling.

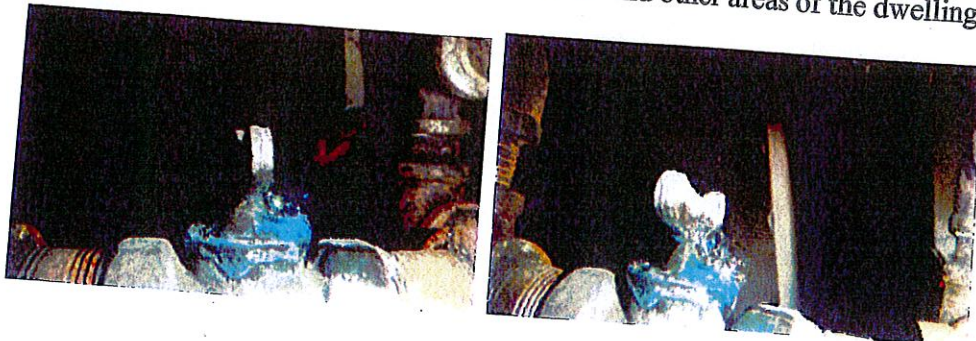
Our fire scene investigation was conducted using the "scientific Method" of fire investigation. The accepted indicators included witness statements, burn patterns, height of burn, direction of burn, electrical arc mapping and propagation of fire. The indicators document the area as being in the basement of the dwelling.

The burn patterns indicate the fire was in the basement and propagated to other areas of the dwelling. Examination of the gas utility revealed not indicator or burn patterns to support the a fire from outside the dwelling or the migration of gas from an external source.
